NASA TECHNICAL MEMORANDUM

NASA TM X-64903

ACCELERATIONS EXPERIENCED DURING LOW-G FLIGHT OF BLACK BRANT VC (NAS 21.015) ON OCTOBER 4, 1974

By Ralph Kissel

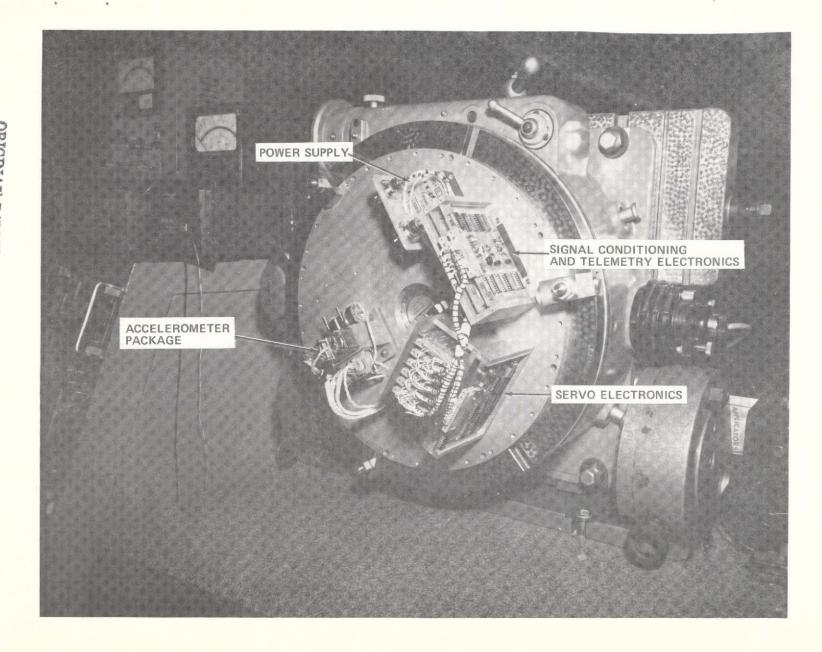
Figure 1. A view of the LGAS assembly.

The LGAS mounted on the flight plate is shown in Figure 1. It consists of four basic assemblies: (1) three Kearfott C70-2412 accelerometers orthogonally mounted on a constant temperature block in a hermatically sealed enclosure; (2) the commercial power supply; (3) the telemetry electronics; and (4) the signal conditioning electronics which converts each accelerometer's output from a voltage (which is proportional to the force required to restore the accelerometers pendulus mass to its null position) to a 19-bit binary word.

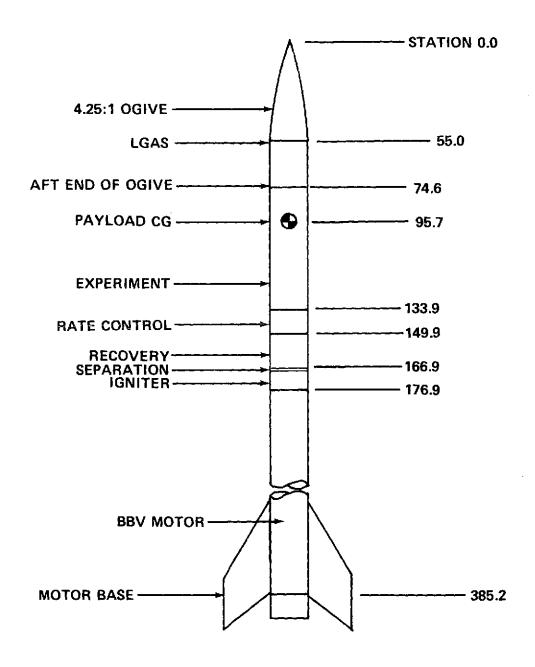
Figure 2. The Black Brant VC configuration.

Figure 2 shows the significant parts of the Black Brant VC NAS 21.015. The LGAS was at station 55.0, which means 55.0 inches from the tip of the nose. The payload center of gravity (CG) was at station 95.7.

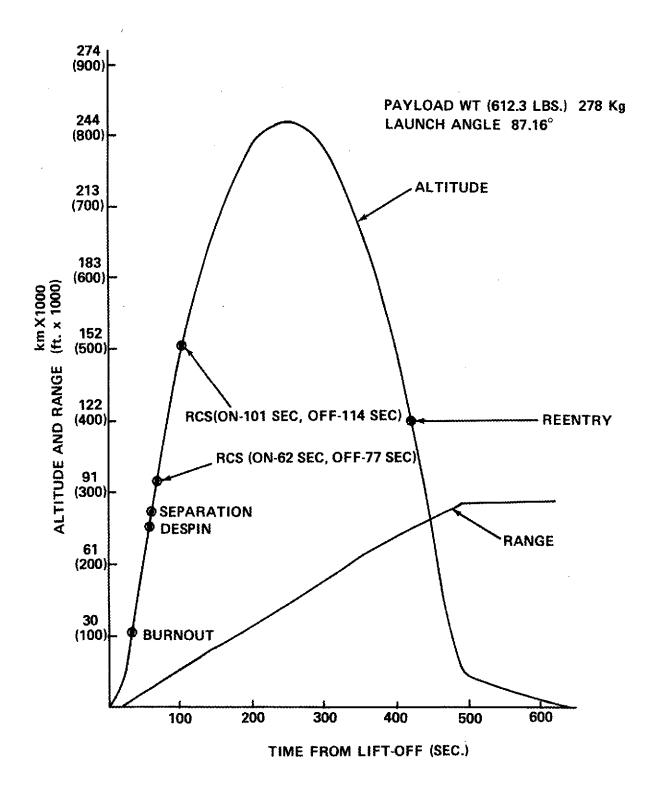
Figure 3. Predicted flight profile and events.

Figure 3 shows the predicted flight profile for this flight. Zero-g begins just after despin which occurred at just above 91.6 km (300 000 ft). The RCS was fired twice, as indicated. Reentry occurred at about 121.9 km (400 000 ft).

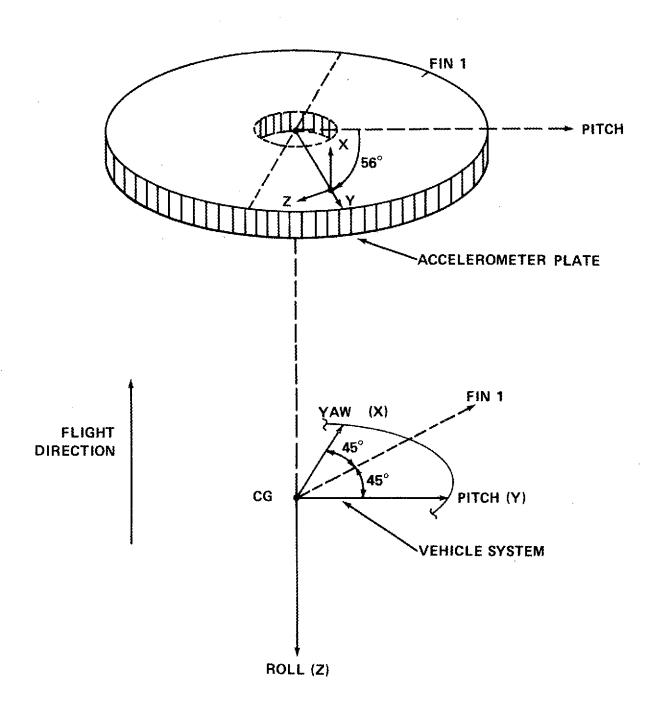
Figure 4. Coordinate systems.

The accelerometer coordinate system used by MSFC and the vehicle coordinate system used by GSFC are related as shown in Figure 4. The accelerometer system is a left-hand system and requires that calculated accelerations along the z-axis be reversed in sign to agree with actual z-axis data.

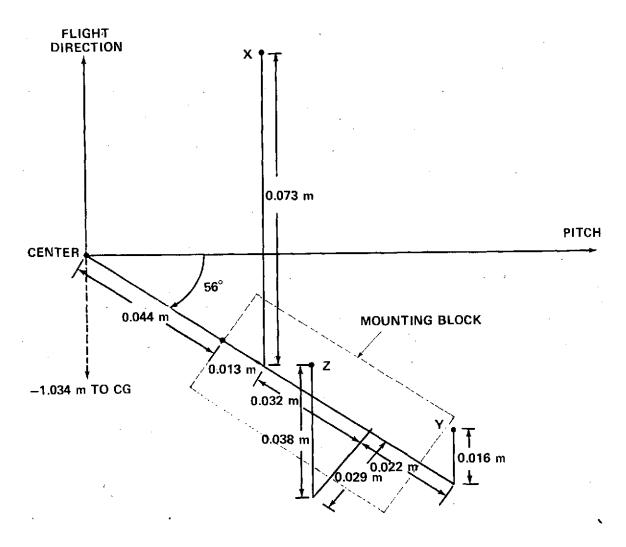
Figure 5. Accelerometer package.

Measurements of the accelerometer package are shown in Figure 5. Note that the accelerometers cannot be at a single point.

Only A_z need be calculated for a_x , but A_y and A_x must each be calculated for both a_y and a_z . Looking at Figure 5, the x-, y-, and z- unit R's are

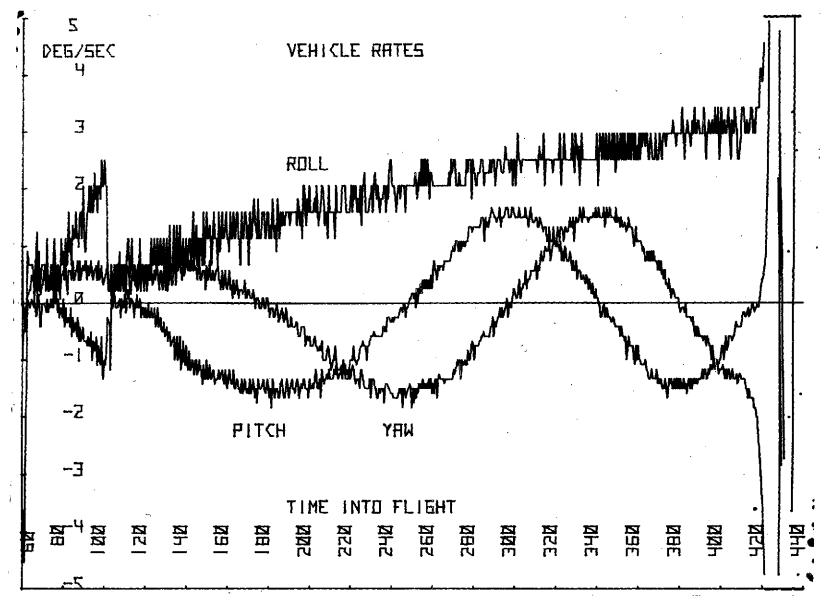
Figure 6. Raw vehicle rate data.

The original rate gyro data (0.5 sec increments) is shown in Figure 6. The quantization error in roll is 0.23 deg/sec [Eq. (8)] and often appears double that amount. The quantization in pitch and yaw is 0.083 deg/sec [Eq. (9)].

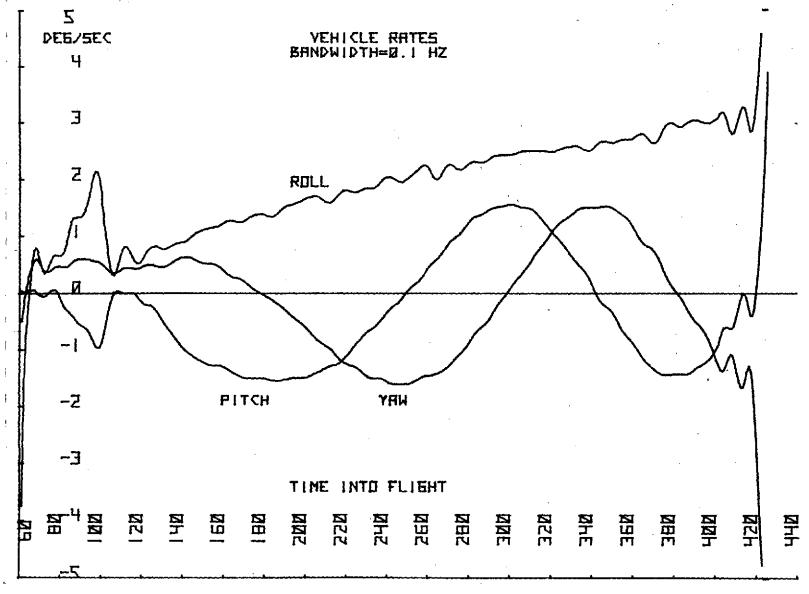
Figure 7. Vehicle rates filtered at 0.1 Hz bandwidth.

Figure 7 shows the rates filtered at 0.1 Hz. The filter, as stated earlier, gives no phase shift. It is a symmetrical filter, which means it looks at just as many points ahead of the present point as behind. Since as many as 100 points (for 0.01 Hz bandwidth) either side of the present point were used, a scheme had to be worked out to start with just one point and end with just one. Otherwise, no data would appear closer than 100 points from either end. The technique was to increase the number of points used going away from either end until the desired number was reached, and then use that number for the main portion of the curve. Noisy data filtered this way shows some oscillation at both ends of the curve. Figure 7 has this effect. The filter in this case is also reacting to the large rates which occur at the extreme ends of the original rate curves.

The higher frequency components in the calculated values result from quantization error in the rate data, particularly roll rate. A noticable dip is seen between 330 and 350 sec in Figure 7, and it started about 300 sec. This apparent deceleration caused the extra waves in the calculated accelerations at around 300 sec. There is a similar effect at about 230 sec. The maximum error from this effect is about 25 μ g.

A major unanswered question for the overall zero-g program is: Why do the rates keep building up after the RCS brings them all close to zero? Twice, the rates were all brought down to the RCS minimum; both times they increased again. Figure 7 shows that the second buildup was considerably

slower than the first. This implies that aerodynamic torques may have been at work (i.e., these are a function of altitude). Total angular momentum increased up to about 170 sec (it varied with pitch rate) and then seemed to decrease again after about 380 sec. These rates were not just passing through the low values, they stayed there until torques made them increase. This could be caused by the RCS thrust valves not closing completely. Post-flight tests at GSFC for one atmosphere pressure showed that they closed. This is the first successful flight in which the RCS was not allowed to activate during most of the flight, so these rate increases were not noticed before.

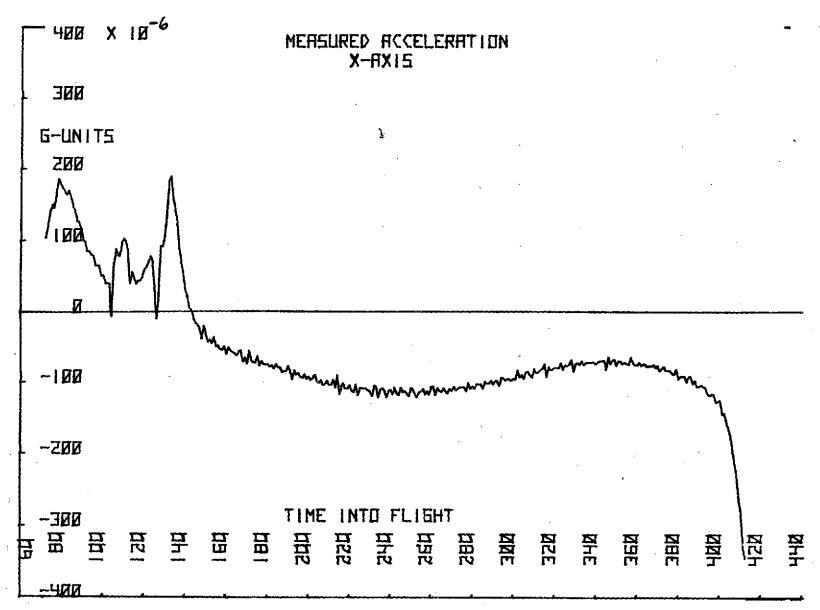
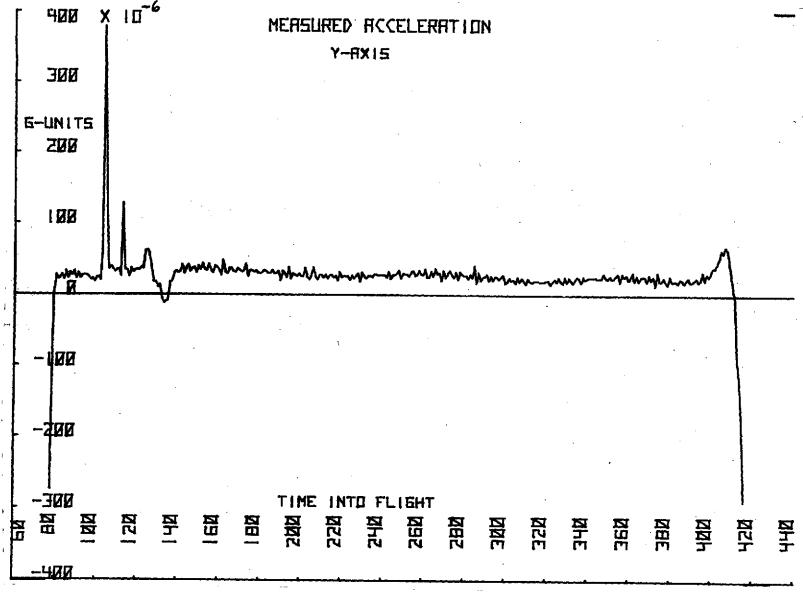
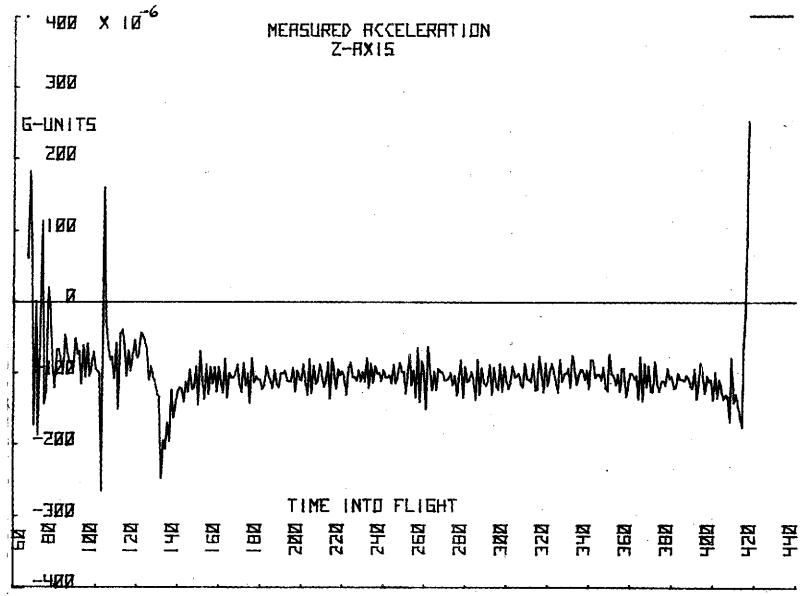
Figures 8, 9, and 10 show the original raw accelerometer data (1.0 sec increments) for the x, y, and z (MSFC coordinates) accelerometers, respectively. The ordinate is given in millionths of a g (μ g). Figure 11 shows all three sets of data on one graph. These data used the preflight calibration parameters.

As expected, Figures 8, 9, and 10 show when the RCS was turned on and off the second time. At 101 and 114 sec, all three axes measured a noticeable rate change. The first RCS firing cannot be seen. The cause of the accelerations which peak at about 80 and 110 sec in x and at about 135 sec in all three axes is not known. One possibility is that the 0.04 g experiment thruster solenoid did not close completely. This would explain the x-axis positive acceleration. Note that when the RCS came on and nulled the rates that the x-axis acceleration increased, which is saying that the negative (it can never be positive) acceleration produced by vehicle rate. was only cancelling part of a larger, positive, thrust produced acceleration. Post-flight examination showed this thrust valve to be closed, as it should be. The possibility exists that it closed at 150 sec. Another possibility is that turning on high power to various heat pipes caused electromagnetic reactions, surging of fluid in the pipes and/or the gas phase of the liquid in the pipe to escape through the leak in one pipe, producing the equivalent of a small thruster. One of the pipes leaked before flight and during flight, and a camera lens fogged at 175 sec.

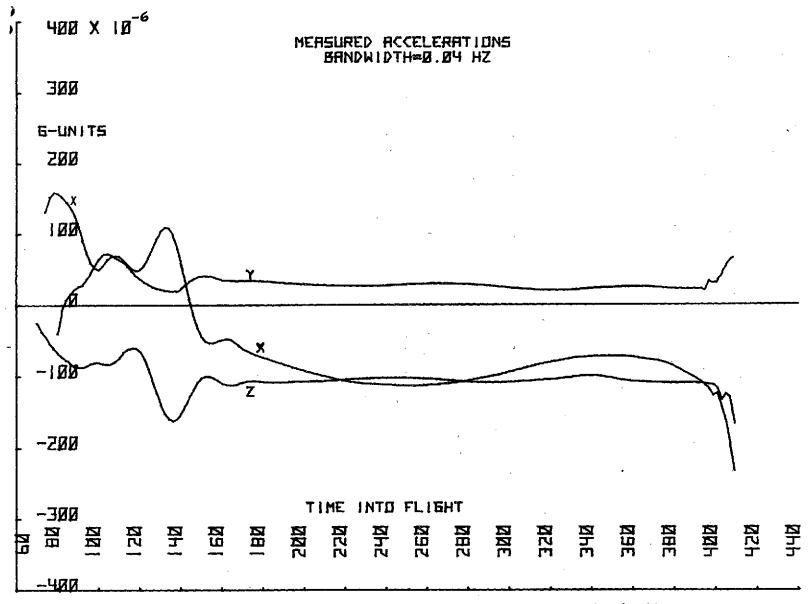
Figure 12. Composite accelerometer data, 0.04 Hz bandwidth.

Figure 12 shows the data in Figure 11 filtered to 0.04 Hz. The filter effect can just be seen at the end of the curves.

Most of the effort in this task was to find out why the measured accelerations (Figure 12 in particular) did not agree exactly with the calculated accelerations in Figure 13. They obviously are not exactly alike. All mathematics and programing were checked for accuracy several times so that these kinds of errors should not be a factor. Each accelerometer has its position known accurately, relative to the payload CG. The rates are relatively crude but were measured values. No other factors exist in calculating the accelerations caused by rate. Filtering makes it impossible to see sharp peaks, but doesn't alter frequencies below the cutoff frequency.

A comparison of Figures 12 and 13 shows that while the shapes are similar, three basic differences which have not already been covered, need to be explained: (1) acceleration levels are shifted, (2) higher frequency components appear in the calculated data than were measured, and (3) the calculated y-axis dip at 140 sec is considerably more than measured.

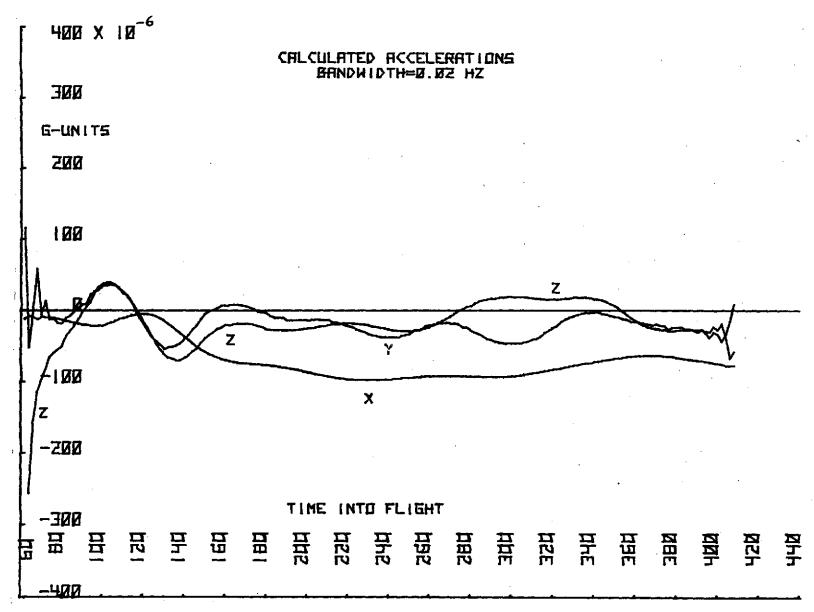
Figure 13. Calculated accelerations, 0.02 Hz bandwidth.

Figure 13 shows the accelerations as actually calculated, using Equations (2) through (7) and filtered at 0.02 Hz. The calculated acceleration was so noisy that this bandwidth was about as high as could be used without allowing obvious noise to remain.

Figure 13 shows that at 135 seconds, rates were produced by the accelerations along the y and z axes but very little from that along the x-axis, i.e., thrust still exists. This implies a different direction or possibly a different source of this acceleration as compared to the earlier accelerations along the x-axis only. The disturbances at 126 sec, especially noticeable in the x- and y-axes, are the beginning of the large accelerations at 135 sec. (Maximum heat was applied to the glass heat pipe experiment at approximately 130 sec.)

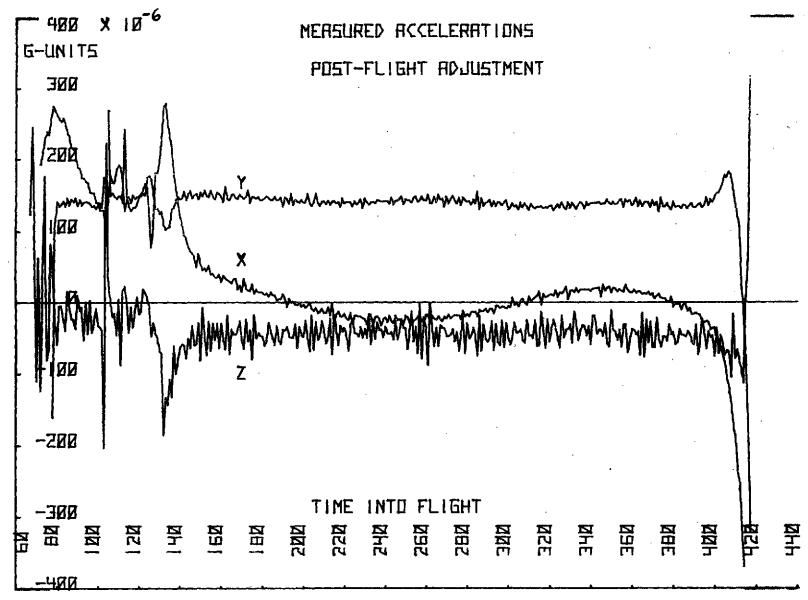
Figure 14. Measured accelerations, post-flight adjustment.

Figure 14 shows the measured accelerations with post-flight determined level-shifts for each accelerometer. These accelerations were what detailed laboratory tests indicate actually existed, if the accelerometer systems performed in flight as they do now.

Detailed post-flight recalibration has shown that each axis indeed has a different zero-crossing frequency than was determined preflight. The changes are shown in Table 2, and Figure 14 shows the data shifted accordingly. It is not certain what caused these differences. Since this testing was done post-flight, something could have even changed in the systems from flight time to laboratory test time, e.g., a hard landing, which did occur. Also, the manufacturer's specification for accelerometer stability is $50~\mu g/3~mo$.

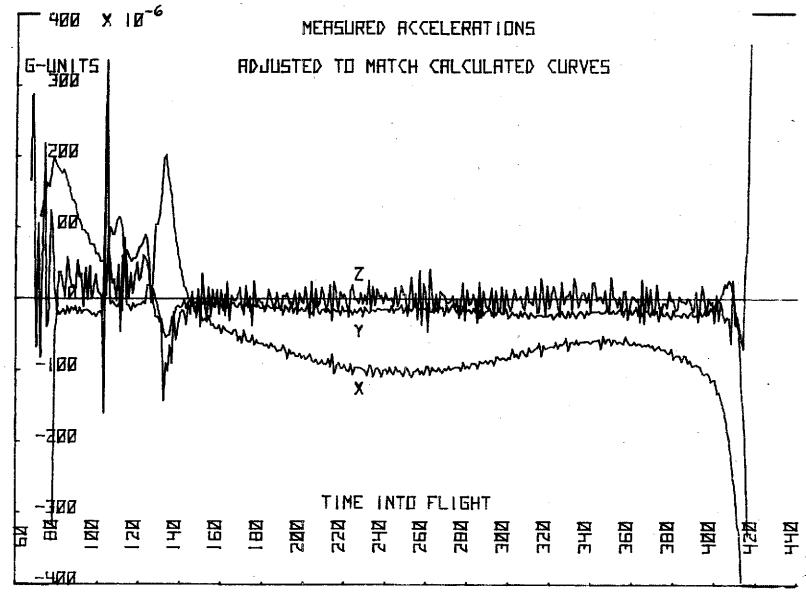
Figure 15. Measured accelerations, computer adjusted.

Figure 15 shows the measured accelerations level-shifted to match the calculated curves between 150 and 420 sec.

The third and deciding set of data, the calculated curves, gives a still different set of shifts. It is this author's belief that Figure 15 most accurately describes the acceleration during the flight. The main reason is that all three axes must experience accelerations similar to those shown, especially beyond 150 sec where the x-accelerometer must have a large average negative acceleration because it is far above and measuring directly away from the CG on the coning payload. The y-accelerometer must have a
